Manhole Inspection Summary

Manhole # S43A2_013MH

Insp Date: **12/10/07 7:52 AM**

Location Address: **937 E Patapsco Ave**

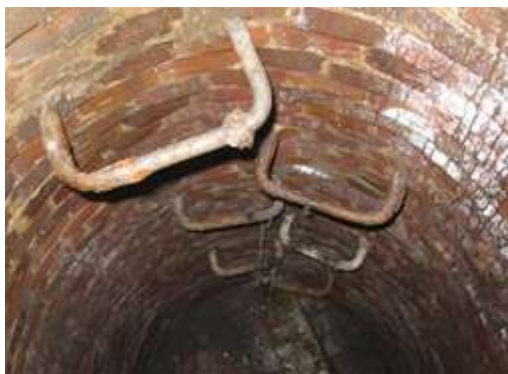
Steps

Count: **6** Missing: **0** ☐ Corroded

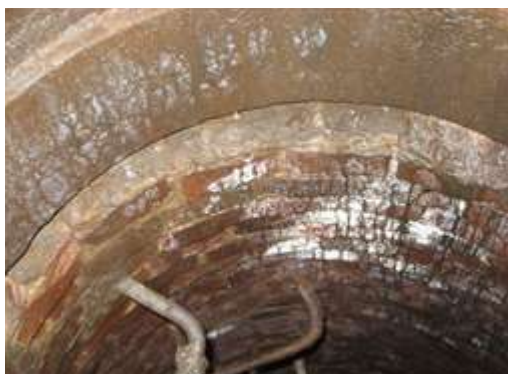
Defect 1

Offset: **2** (in.)

Frame offset

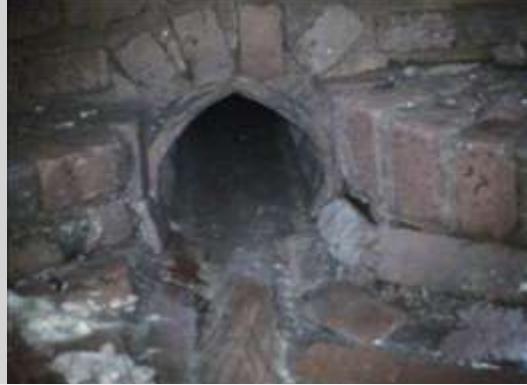
12 O'Clock Outflow

8 in. Circular Gravity Sewer
Pipe Out @ 12 O'Clock

Pipe Height: **9.6** (in.) Rod and Bar (Angled)
Pipe Material: **Clay** ☐ Pipe Lined
Invert Depth: **11.34** (ft.) Flow Characteristics: **Fast**
Deposits: ☒ None ☐ Mud ☐ Sludge ☐ Debris ☐ Grease
Silt Depth: (in.) Deposits Extent:
Infiltration: **None** Pipe Seal Cond: **Sound**

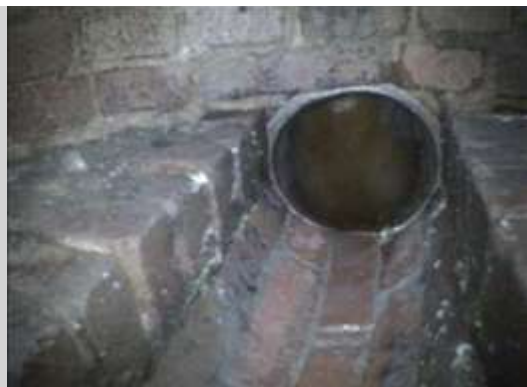
3 O'Clock Inflow

8 in. Circular Gravity Sewer
Pipe In @ 3 O'Clock

Pipe Height: **9.6** (in.) Rod and Bar (Angled)
Pipe Material: **Clay** ☐ Pipe Lined
Invert Depth: **10.90** (ft.) Flow Characteristics: **Fast**
Deposits: ☒ None ☐ Mud ☐ Sludge ☐ Debris ☐ Grease
Silt Depth: (in.) Deposits Extent:
Infiltration: **None** Pipe Seal Cond: **Sound**

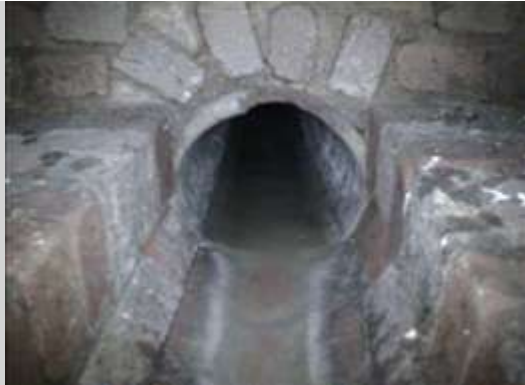
6 O'Clock Inflow

Infiltration: **None** Pipe Seal Cond: **Broken**

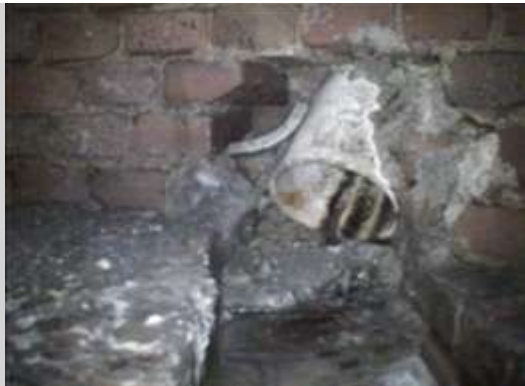
9 O'Clock Inflow

Infiltration: **None** Pipe Seal Cond: **Broken**
